Figure 1. MD Route 464 Catoctin Creek Vicinity Map

MD 464 over Catoctin Creek

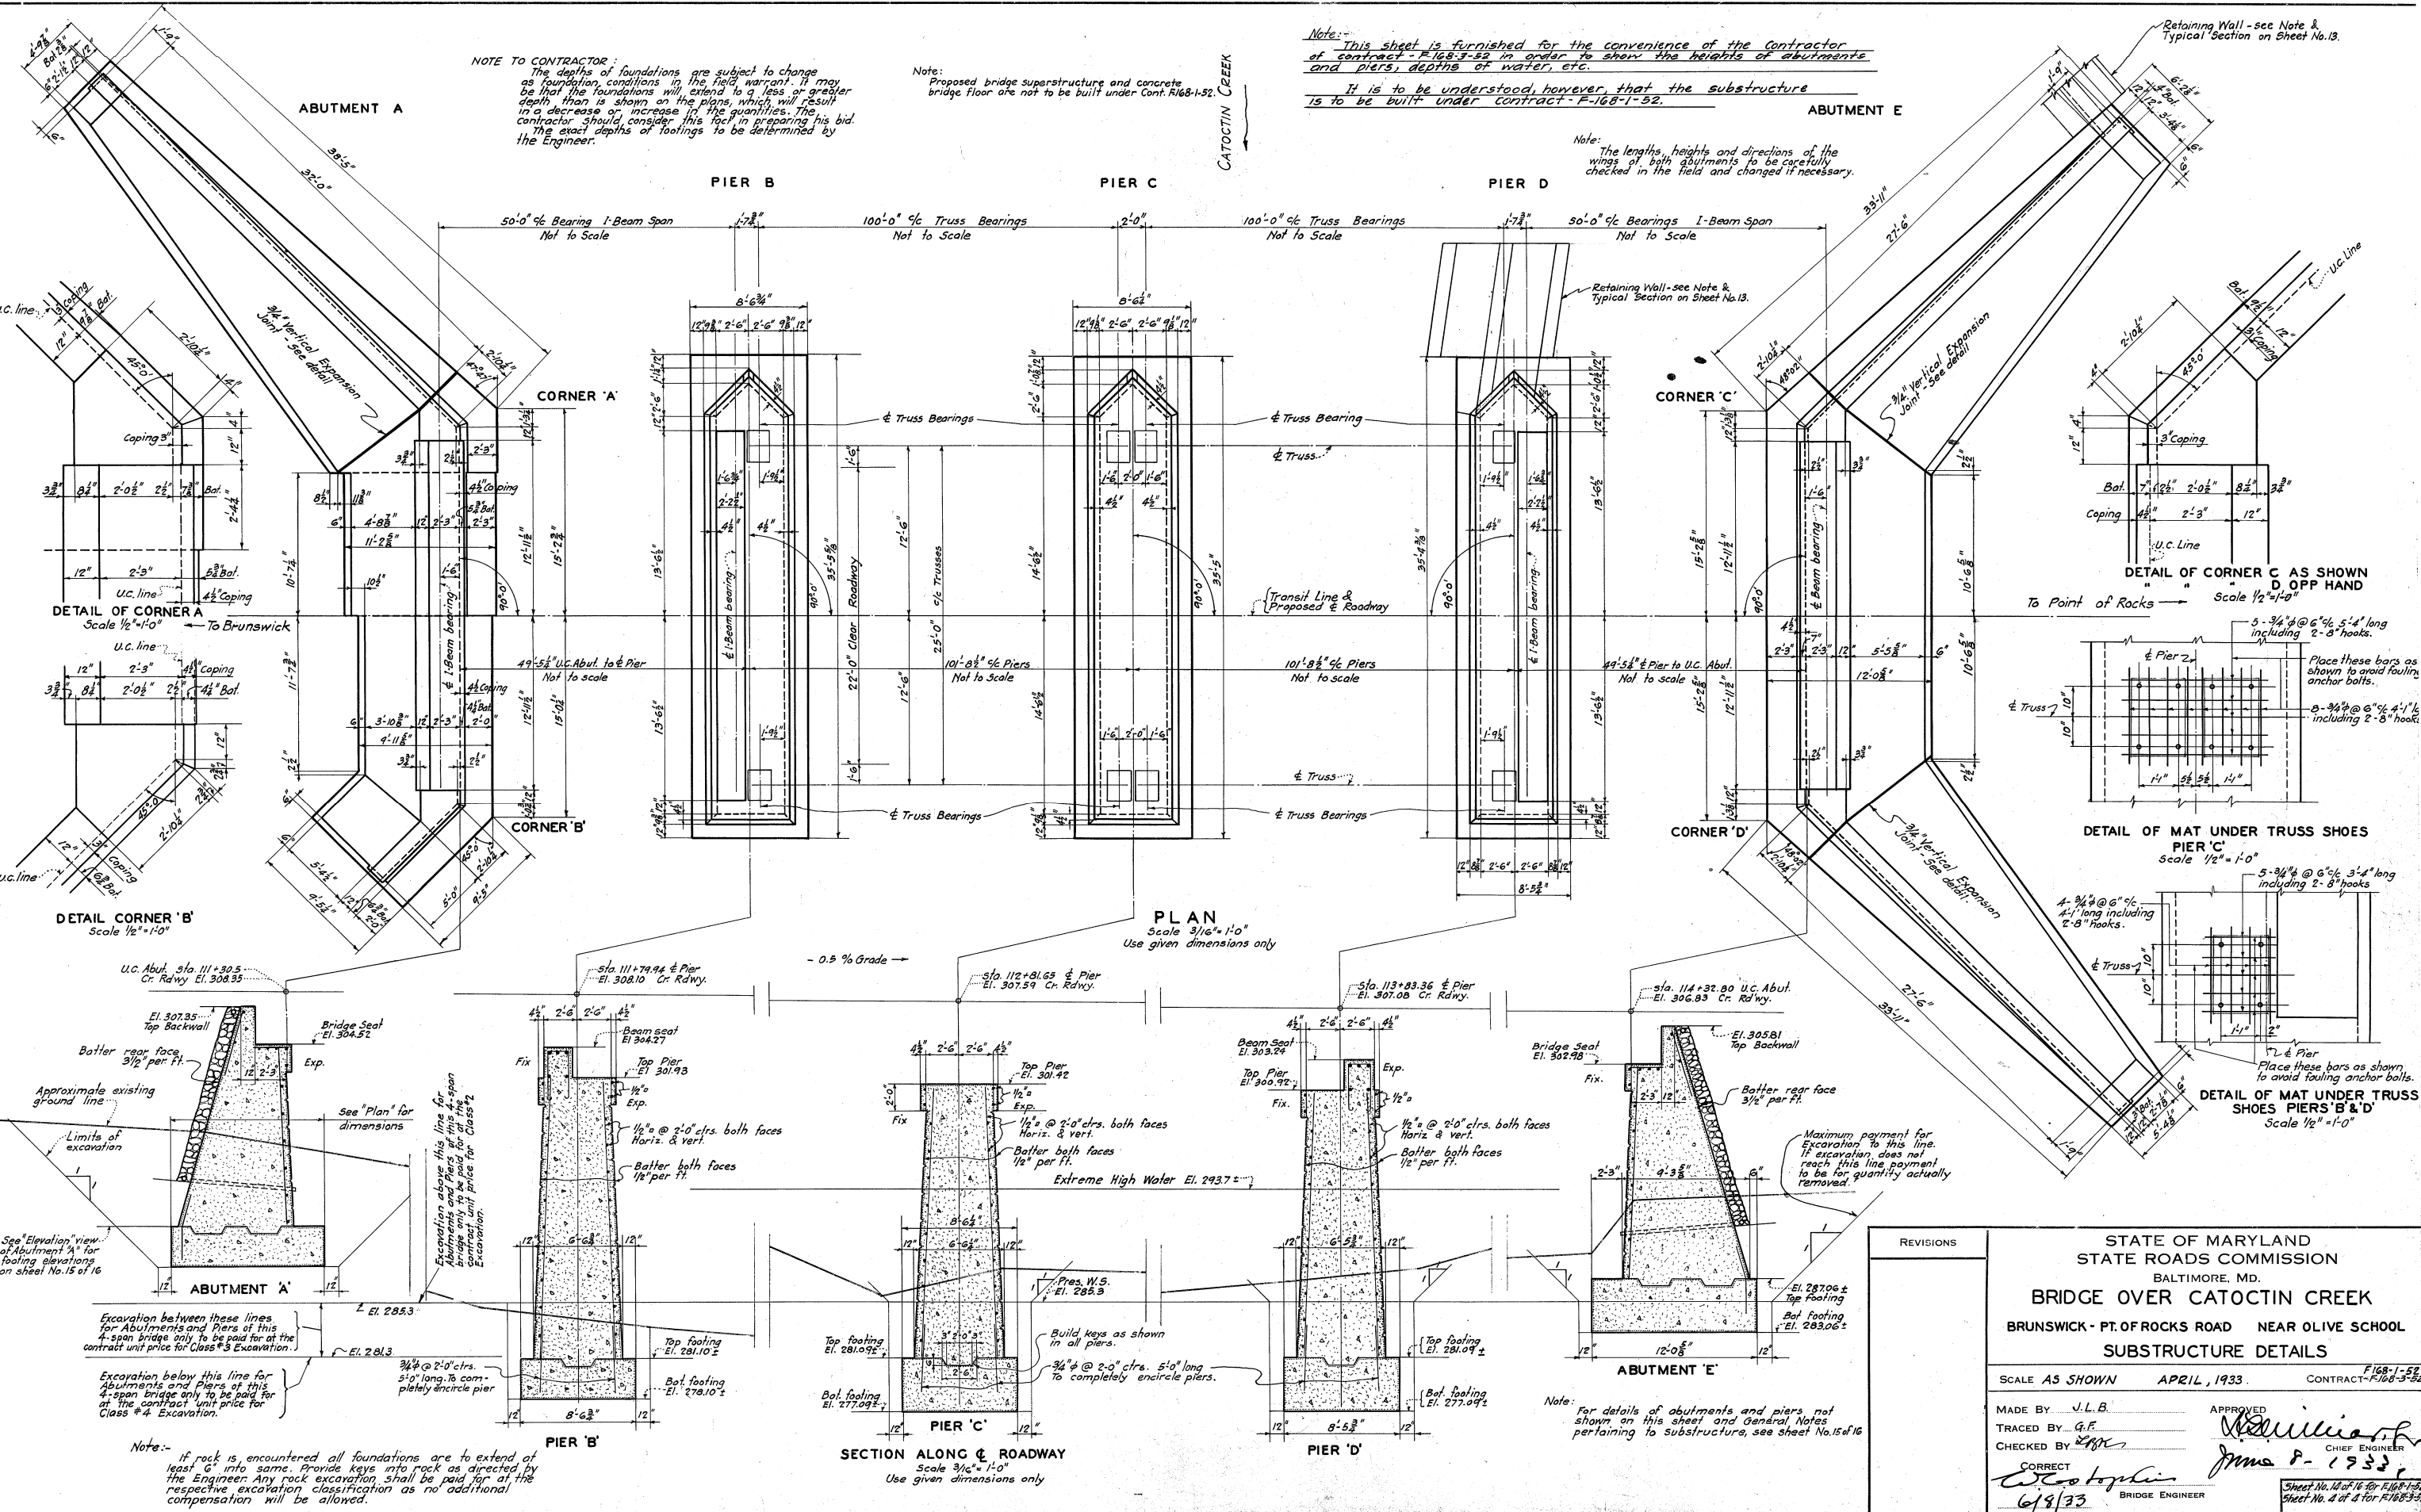
Figure 6. Substructure Details From 1933 Construction Drawings for Current Route 464 Bridge Over Catoctin Creek.

The old bridge plans, dated 1933 and shown in Attachment A, show the previous two-span bridge located with the east abutment approximately 100 feet downstream, between piers C and D of the current bridge; the west abutment was located at Pier B. The

The old bridge plans, dated 1933, show a stone mill dam extending from the west hillside to a land feature between the easternmost pier (Pier D) and the east abutment of the proposed bridge. That land feature has since eroded away, leaving the two retaining walls that tied the concrete gates to Pier D and the east abutment. The mill race went over concrete gates along the east abutment to the mill building approximately 1,000 feet downstream. Portions of the retaining wall have collapsed (Photo 91), as have the concrete gates. The remnants are located immediately upstream of Pier D.
