Attachment A:

MD 464 over Catoctin Creek

II. Visual Assessment

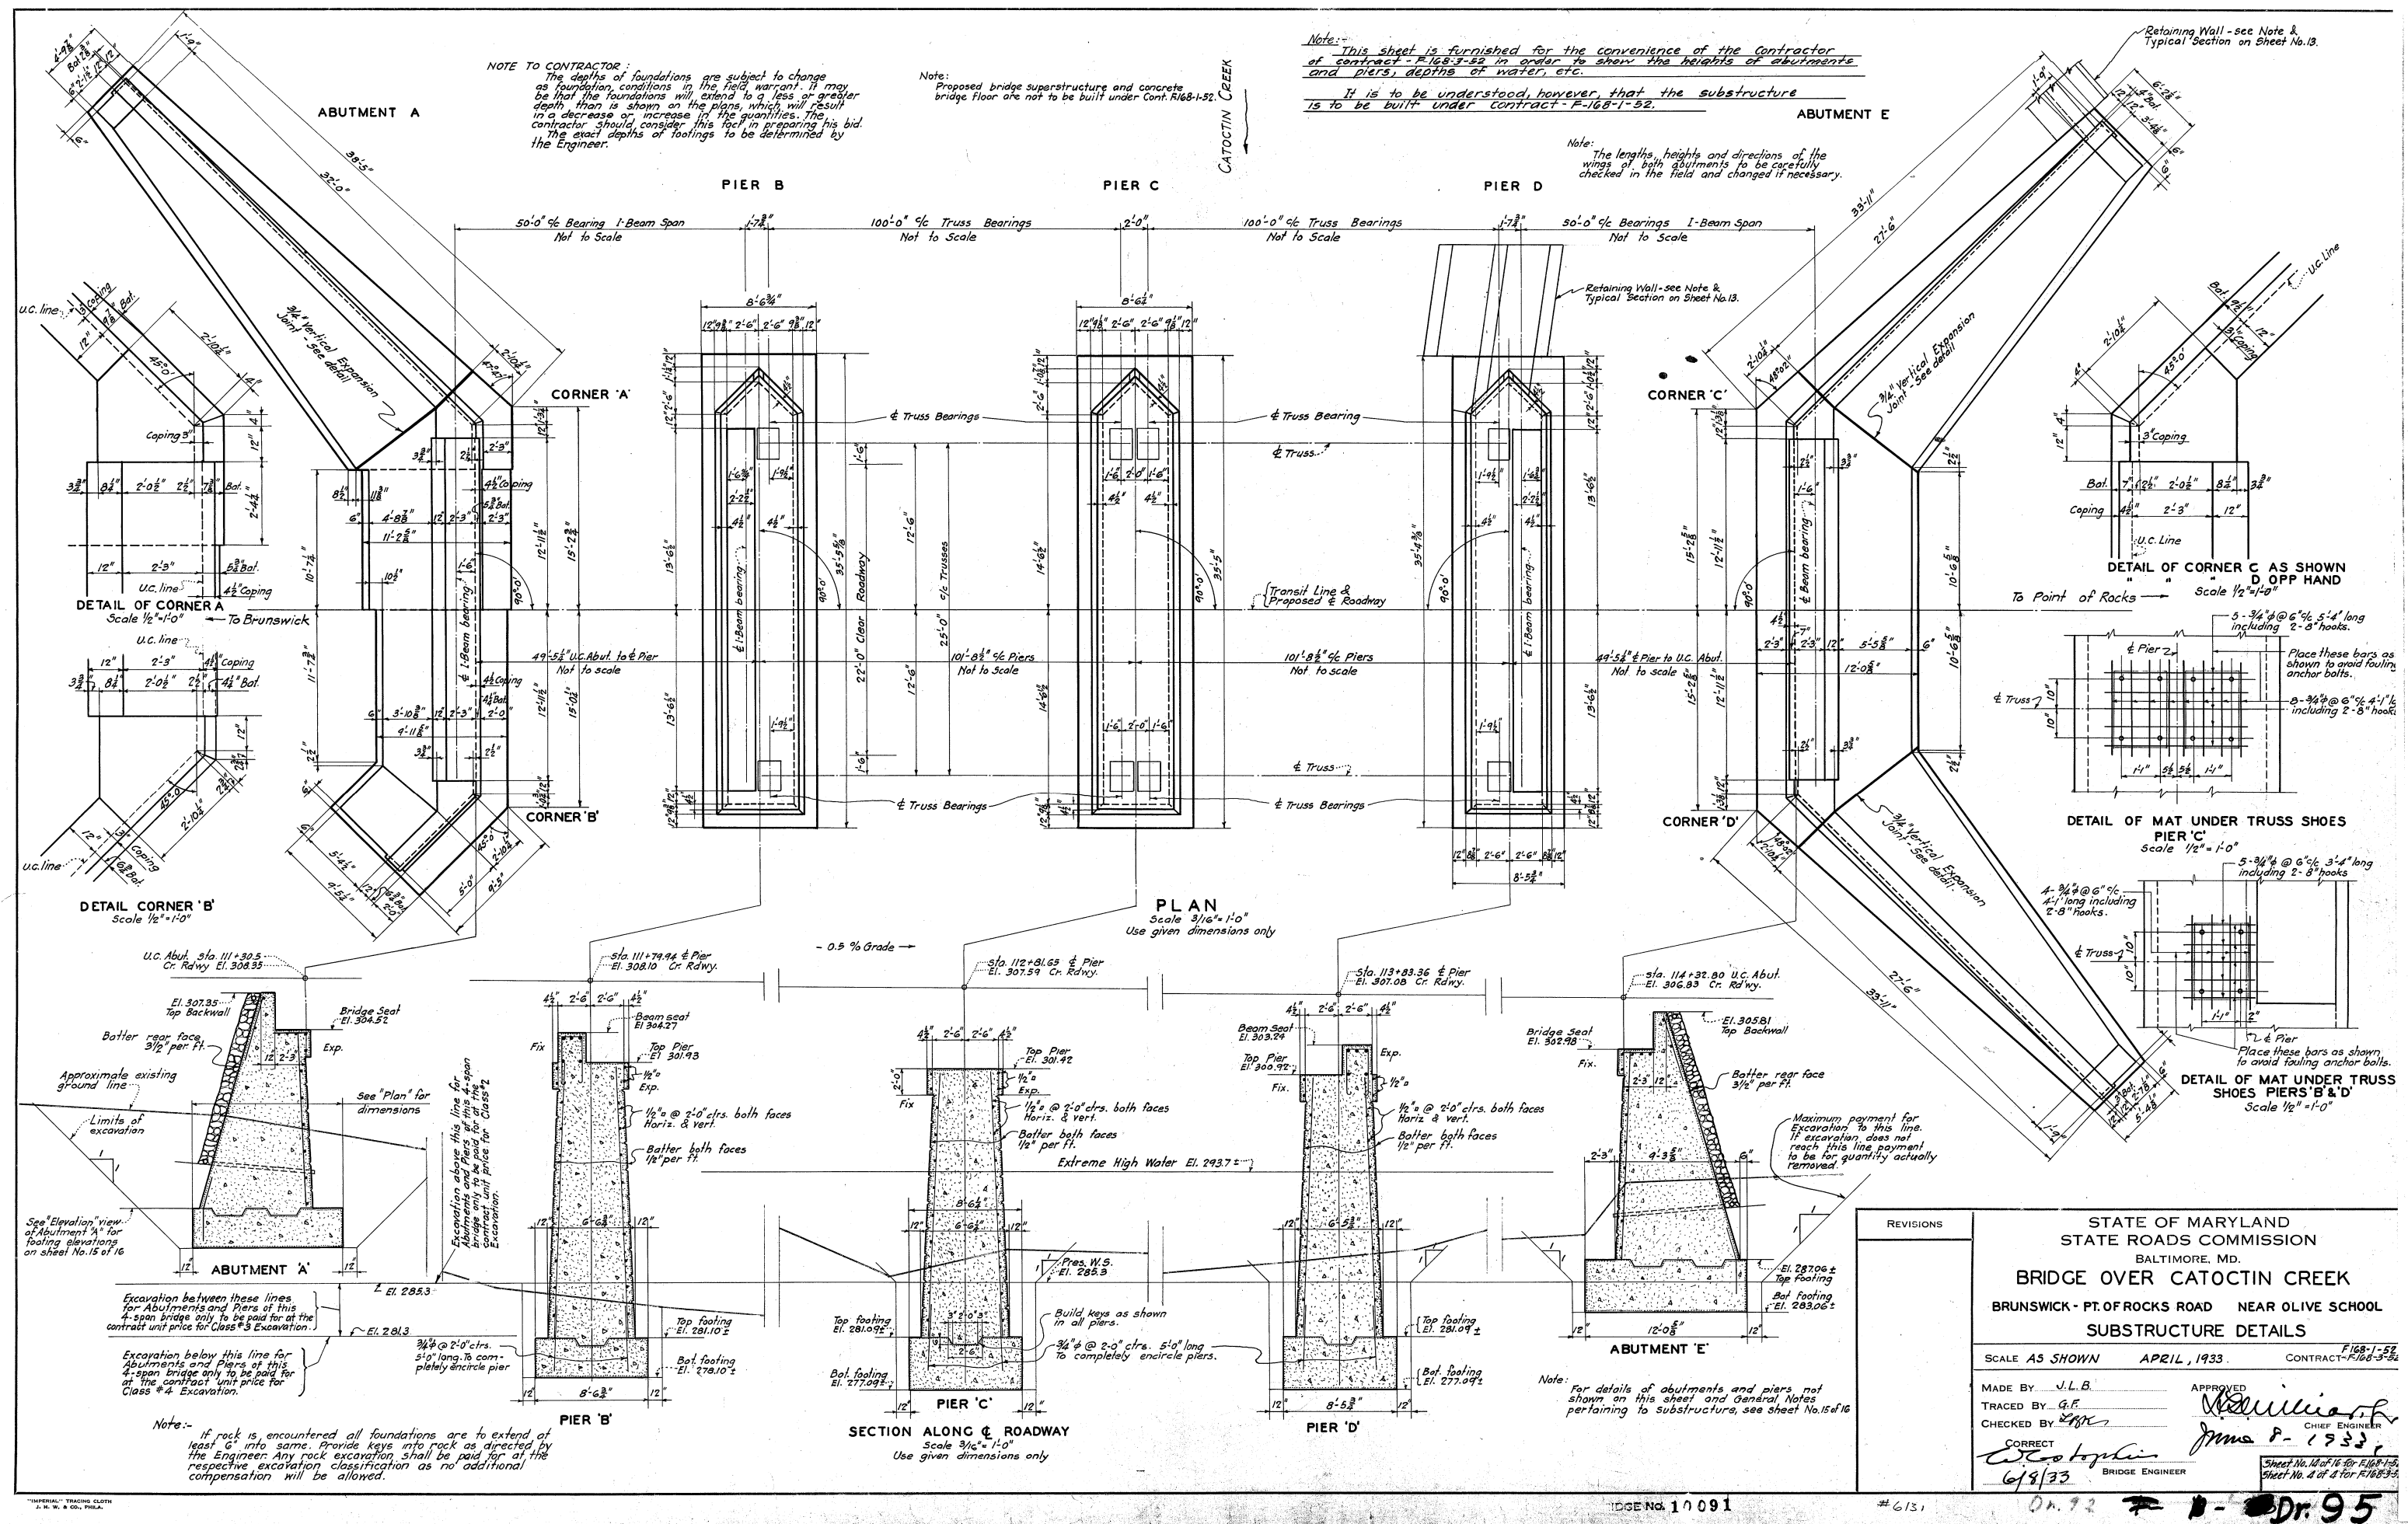
Figure 6. Substructure Details From 1933 Construction Drawings for Current Route 464 Bridge Over Catoctin Creek.

The old bridge plans, dated 1933 and shown in Attachment A, show the previous two-span bridge located with the east abutment approximately 100 feet downstream, between piers C and D of the current bridge; the west abutment was located at Pier B. The

The old bridge plans, dated 1933, show a stone mill dam extending from the west hillside to a land feature between the easternmost pier (Pier D) and the east abutment of the proposed bridge. That land feature has since eroded away, leaving the two retaining walls that tied the concrete gates to Pier D and the east abutment. The mill race went over concrete gates along the east abutment to the mill building approximately 1,000 feet downstream. Portions of the retaining wall have collapsed (Photo 91), as have the concrete gates. The remnants are located immediately upstream of Pier D.

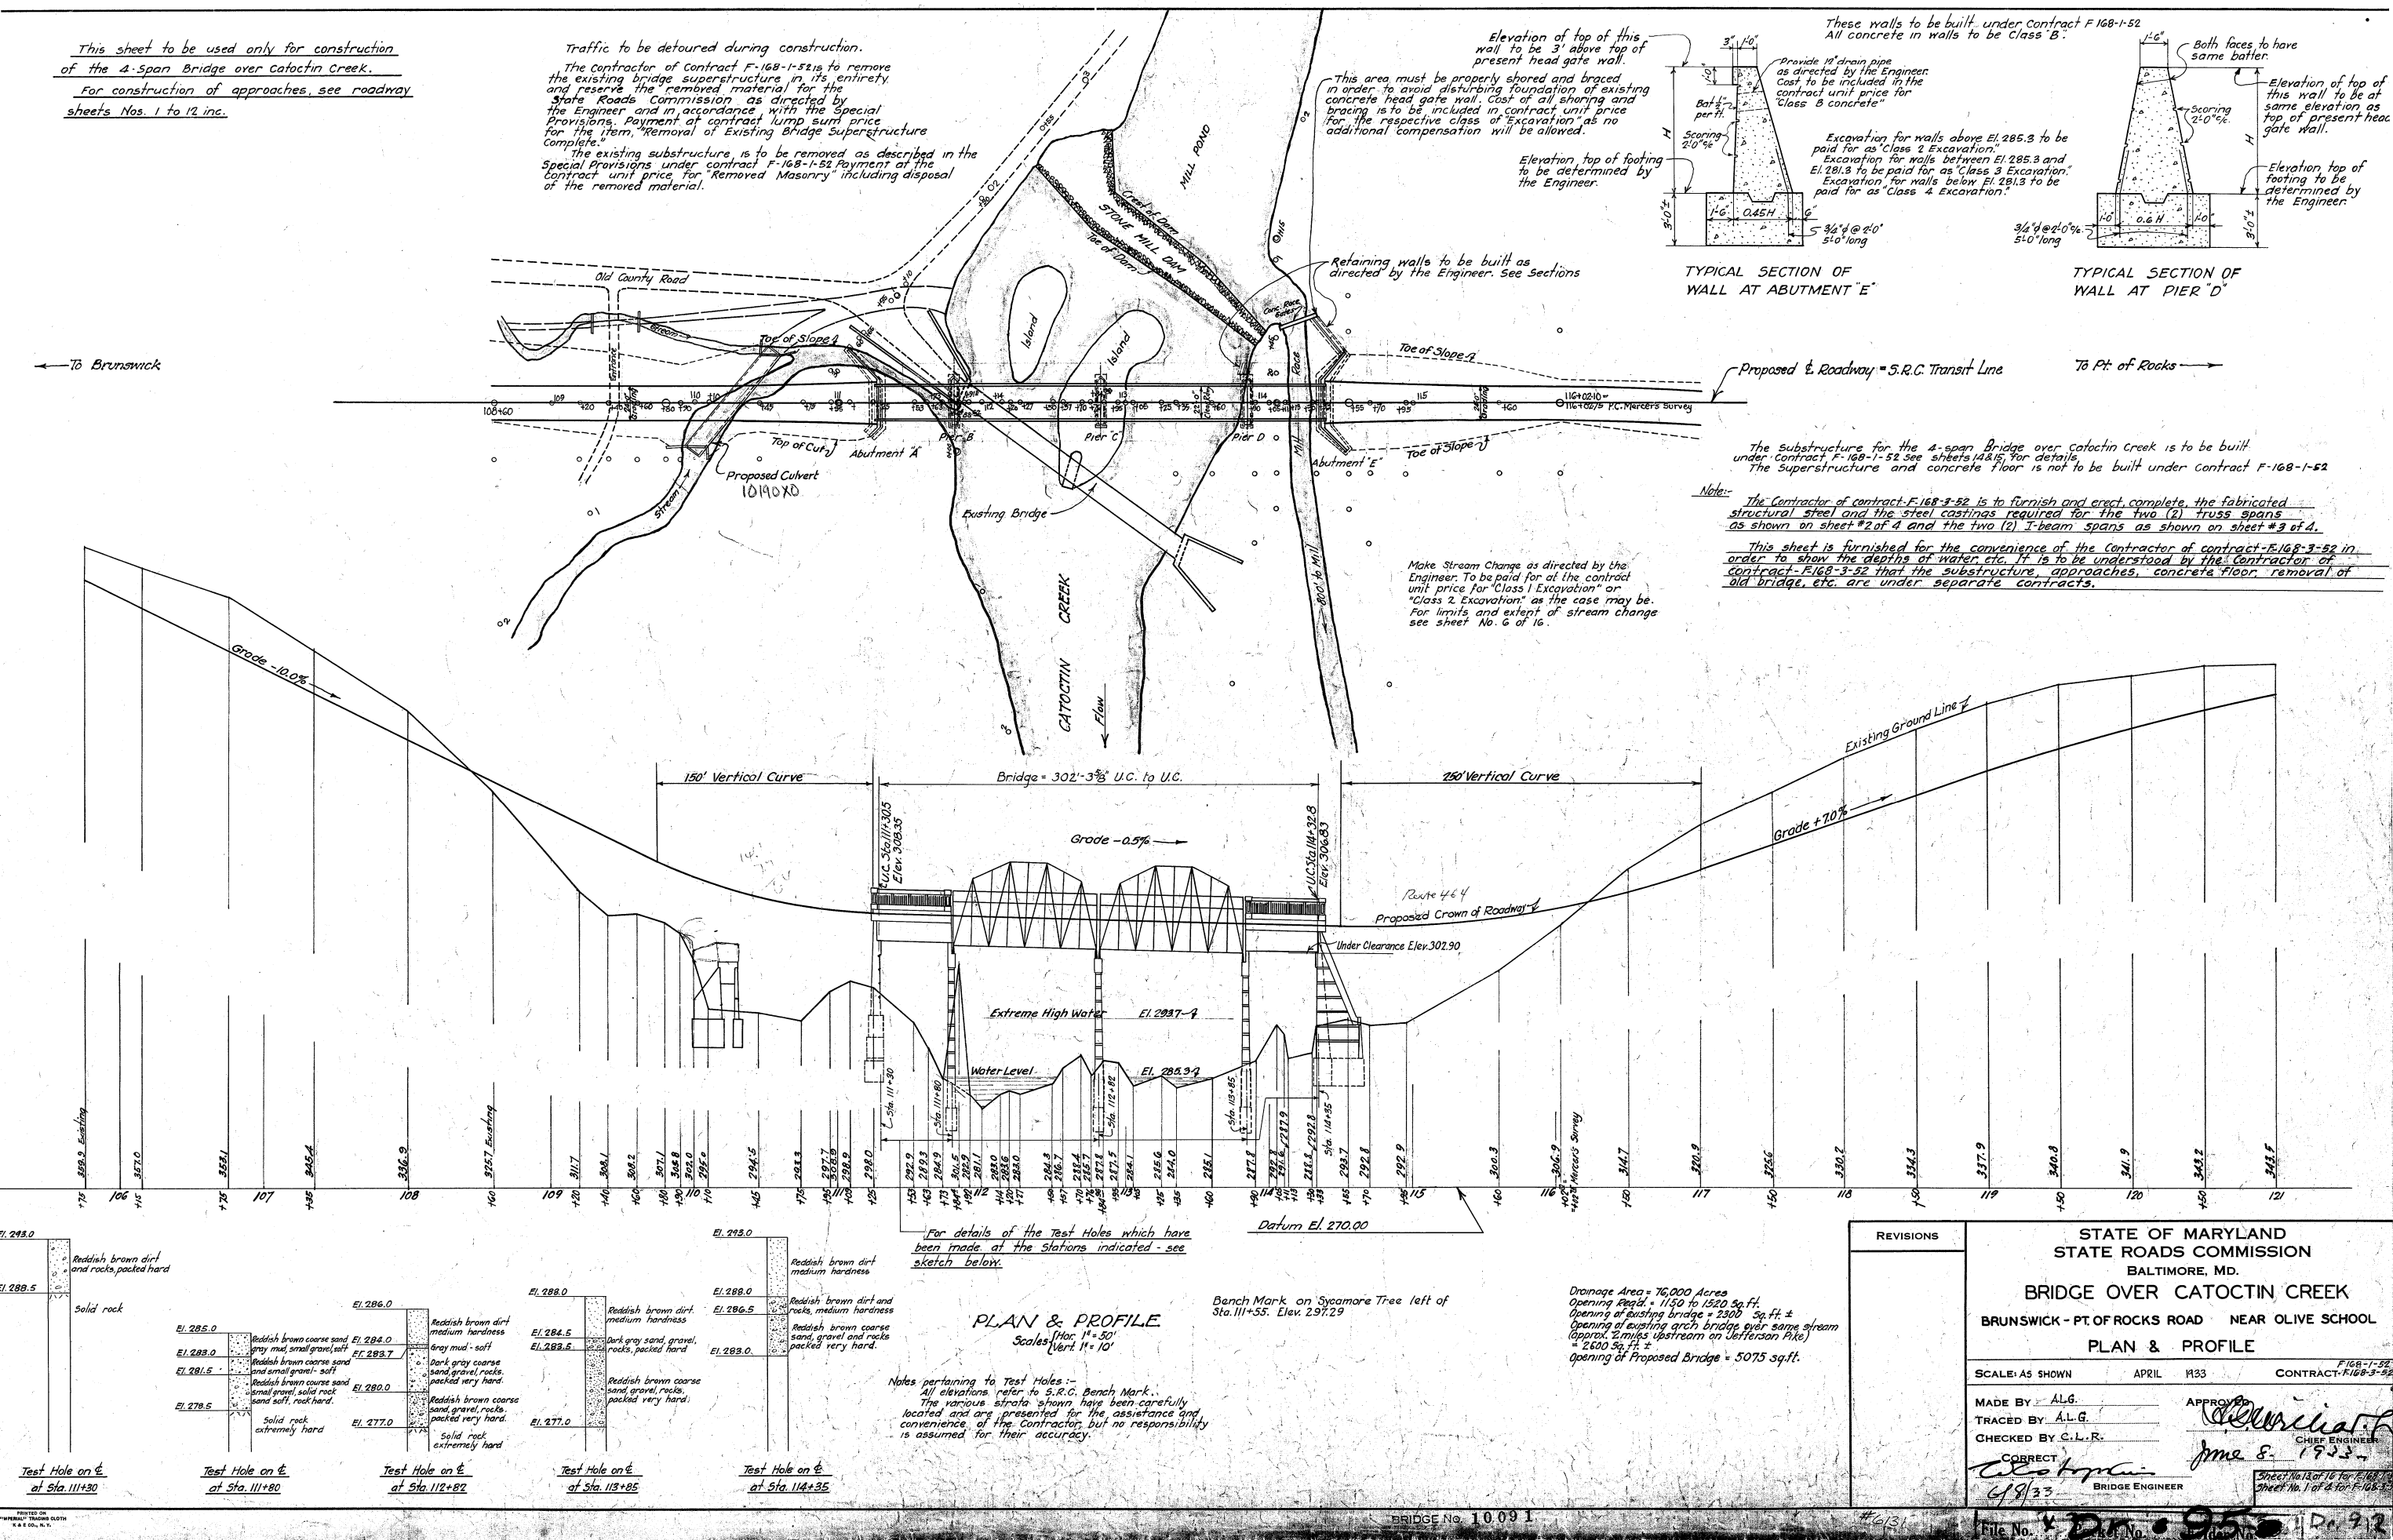
Figure 7. 1933 Plan and Cross Section Views of Current MD Route 464 Bridge Over Catoctin Creek.

The east abutment (Photo 85) is in severe disrepair and currently obstructing exit flows from the bridge. There are no signs of the older pier or east abutment. However, there is significant deposition in the locations of those older substructure units, so any evidence may be buried (Photo 83). Also, the old drawings show two islands between the dam and the 1933 bridge. Currently, the deposition extends from approximately 100 feet downstream to approximately 100 feet upstream of the dam. There has been significant loss of capacity through the bridge since 1933.
