Appendix 14-D: Detailed Study Report Example

Final Stream Geomorphic Report for Intercounty Connector Proposed Crossing BR-21 at the Brooke Manor Country Club Tributary of North Branch of Rock Creek

Prepared by Arthur C. Parola, Jr., Ph.D.
and William S. Vesely
Riverine Systems, LLC
Louisville, KY

Submitted August 2005
Revised **February 2006**

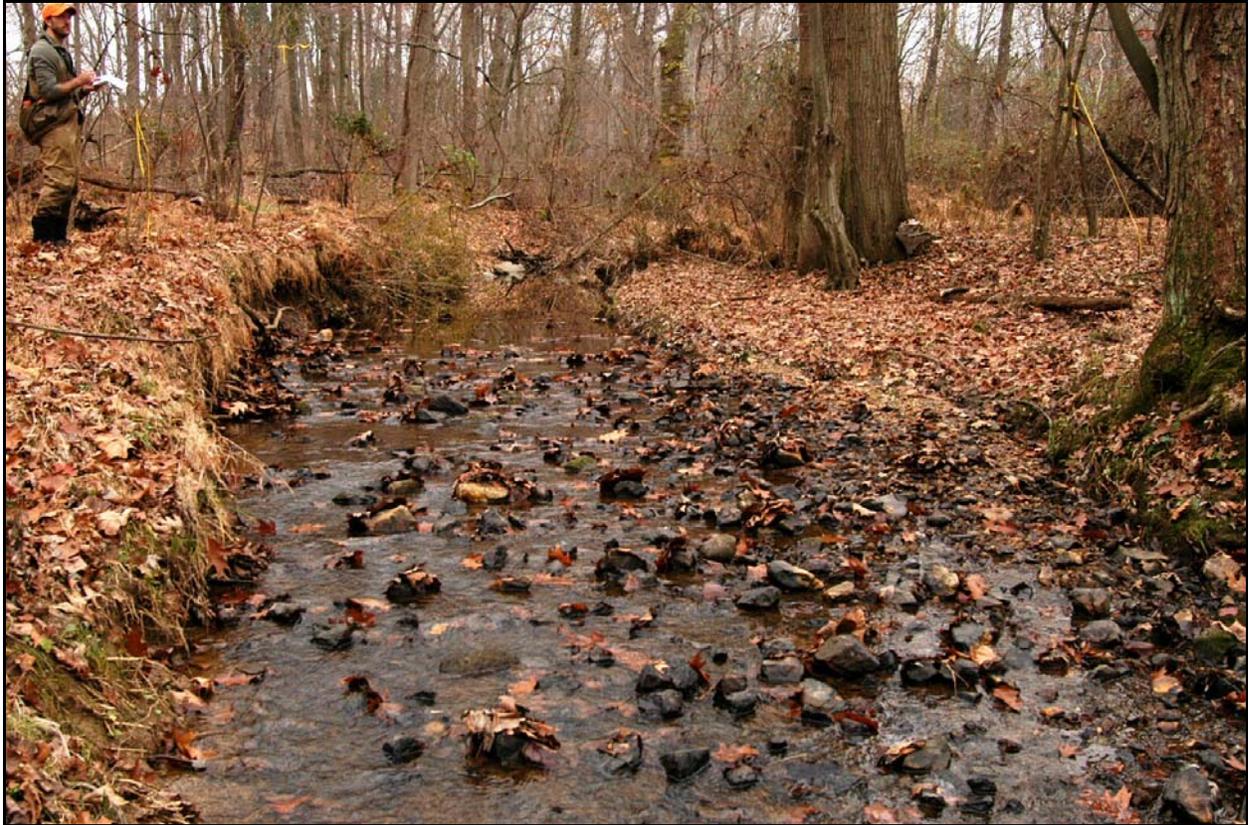
Figure 10 Reach used to assess sediment mobility and bankfull flow estimate. This channel section is typical of some reaches that have migrated away from the straightened alignment.

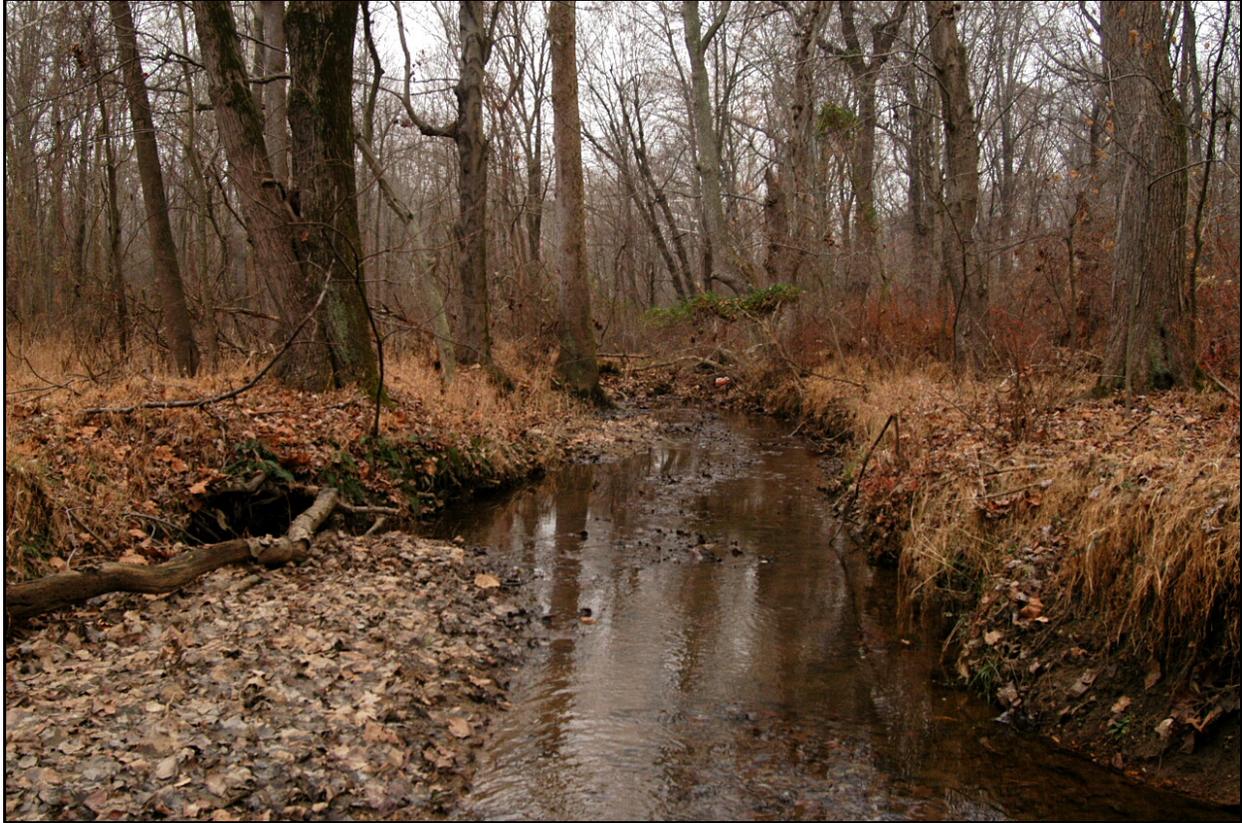
Figure 12 Typical conditions of the stream channel that is widening through bank erosion but has not migrated substantially from the straightened and channelized alignment. A debris jam downstream is causing deposition of fine grain sediment in the channel. View is downstream from Cross Section 2.
